Bell Lime Kiln

Draw kiln.

Built c1860s Used (intermittently) until 1918 Grade II listed 19 December 1984 Images of England number 400677

Emergency repairs 2009 & 2017

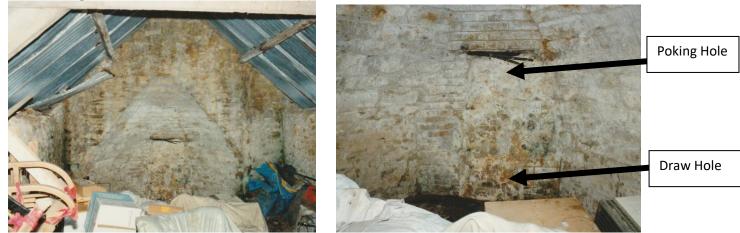
Images 1990

Pointed Draw Arch, stone lined The poking and draw holes were filled in after an animal had fallen in to the pot c1940.

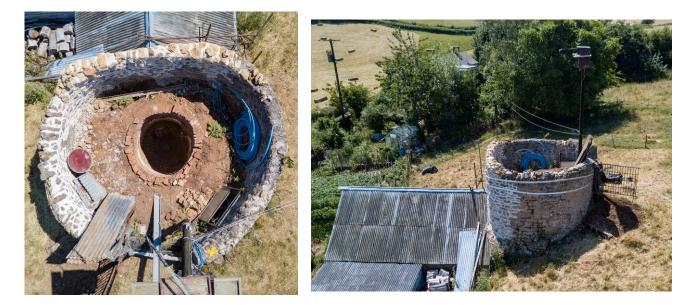
Inside of pot Grate

Water ingress into the walls had washed away the fox mould infill and the lime mortar had failed. Portland cement had been used in the past to make repairs.

The fill between the inner pot and outer structure was saturated and forced the outer walls apart. Straps retained the walls while repairs were carried out. Some larger local stones were used to bind the walls together. Further repairs are currently being carried out to return the top to level and complete replacing missing stones and pointing.
