### Limekilns and Geology

### Limekiln sites and their archaeology

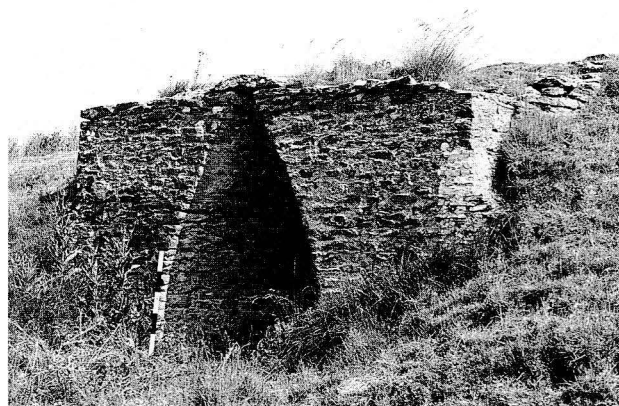
Plate 2. New Lane, Swyre. A small pointed arch Type C limekiln. July 1993.

Some regional groupings are apparent in Figure 4. For example, the Type C pointed arch (Plate 2) is common in west Dorset, where Stevenson described early lime-burning. The view that this is an early style is supported by evidence from Warren Bay in Somerset, where a kiln with a pointed arch was shown to be older than two round-arched kilns (Daniel and Murless 1993, 5). Geology could be a factor, as many Type C kilns are found on

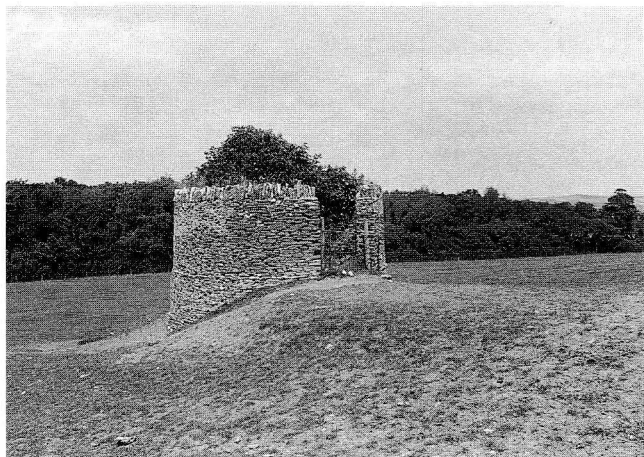
Plate 3. Whitmore Coppice limekiln at Langton Herring from the south, showing the retaining wall (restored) around the kiln head and pot. June 1993.

While many limekilns had a lime shed, at least four had a tunnel approach. The finest is at Whitmore Coppice (Plates 3 and 4, and Figure 6), with others at Penn Wood, Lake and Ridgeway (sites 160, 256 and 279). These kilns could be given their own classification because of such distinct features.

surrounding walls. These are often now ruinous, but enough survive to show they could be low, as at Rodden Ridge (site 4) or Limekiln Hill (site 214), or there was a much higher wall to give protection from the elements, as at Whitmore Coppice (Plate 3), Willwood and Nottingham (sites 77 and 277).

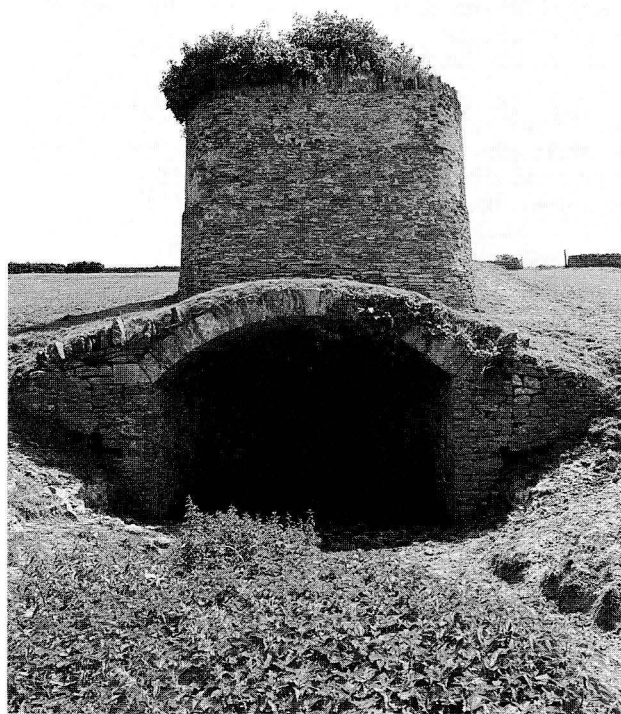
Plate 4. Whitmore Coppice limekiln from the north, showing the unusual tunnel approach to the draw arch area. June 1993.

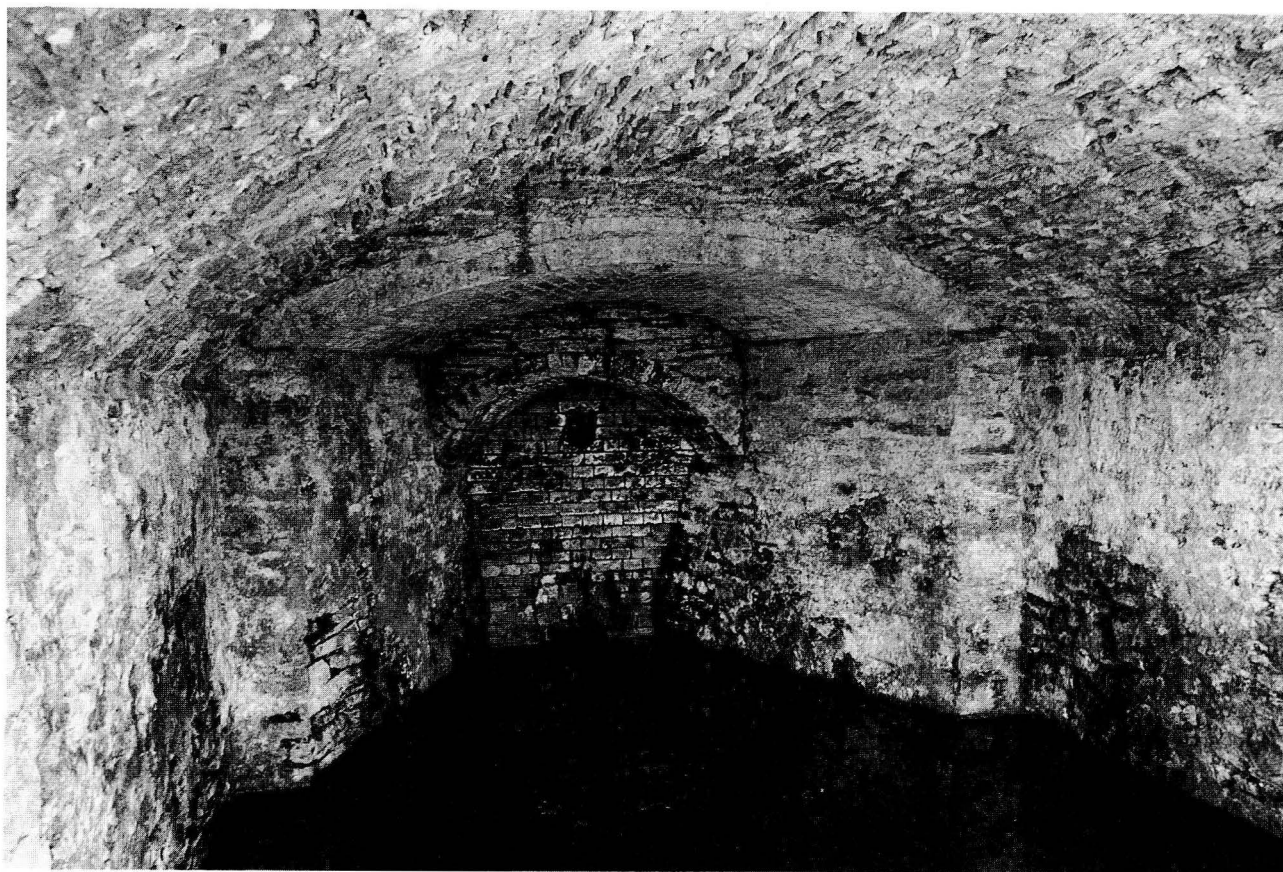
Plate 5. Double draw arches and a high quality of building seen at the Whitmore Coppice limekiln. The site was flooded on the day of the photograph. June 1993.

the Inferior Oolite and Cornbrash/Forest Marble, reflecting those stones' suitability for constructing this simple form of arch. Type B round brick arches are common on the chalk, where flint could not be used. Four of the well-built kilns in the Langton Herring area have double brick arches (see Plate 5). Two remarkably low-centred Type B brick arches were noted in west Dorset, at Gribb Farm (site 128), which has a stone keystone, and at Cogden Farm (site 39), where the bricks have been removed.

Draw-holes were usually rectangular, in stone or with a round brick arch (Plates 5, 6 and 7) and some kilns have evidence of an iron fire door. At Hill Farm (site 289), there was also a lower door for drawing out ash. The smaller poking holes were likewise built in stone or brick (Plates 6 and 7), and show signs of wear if used over long periods.

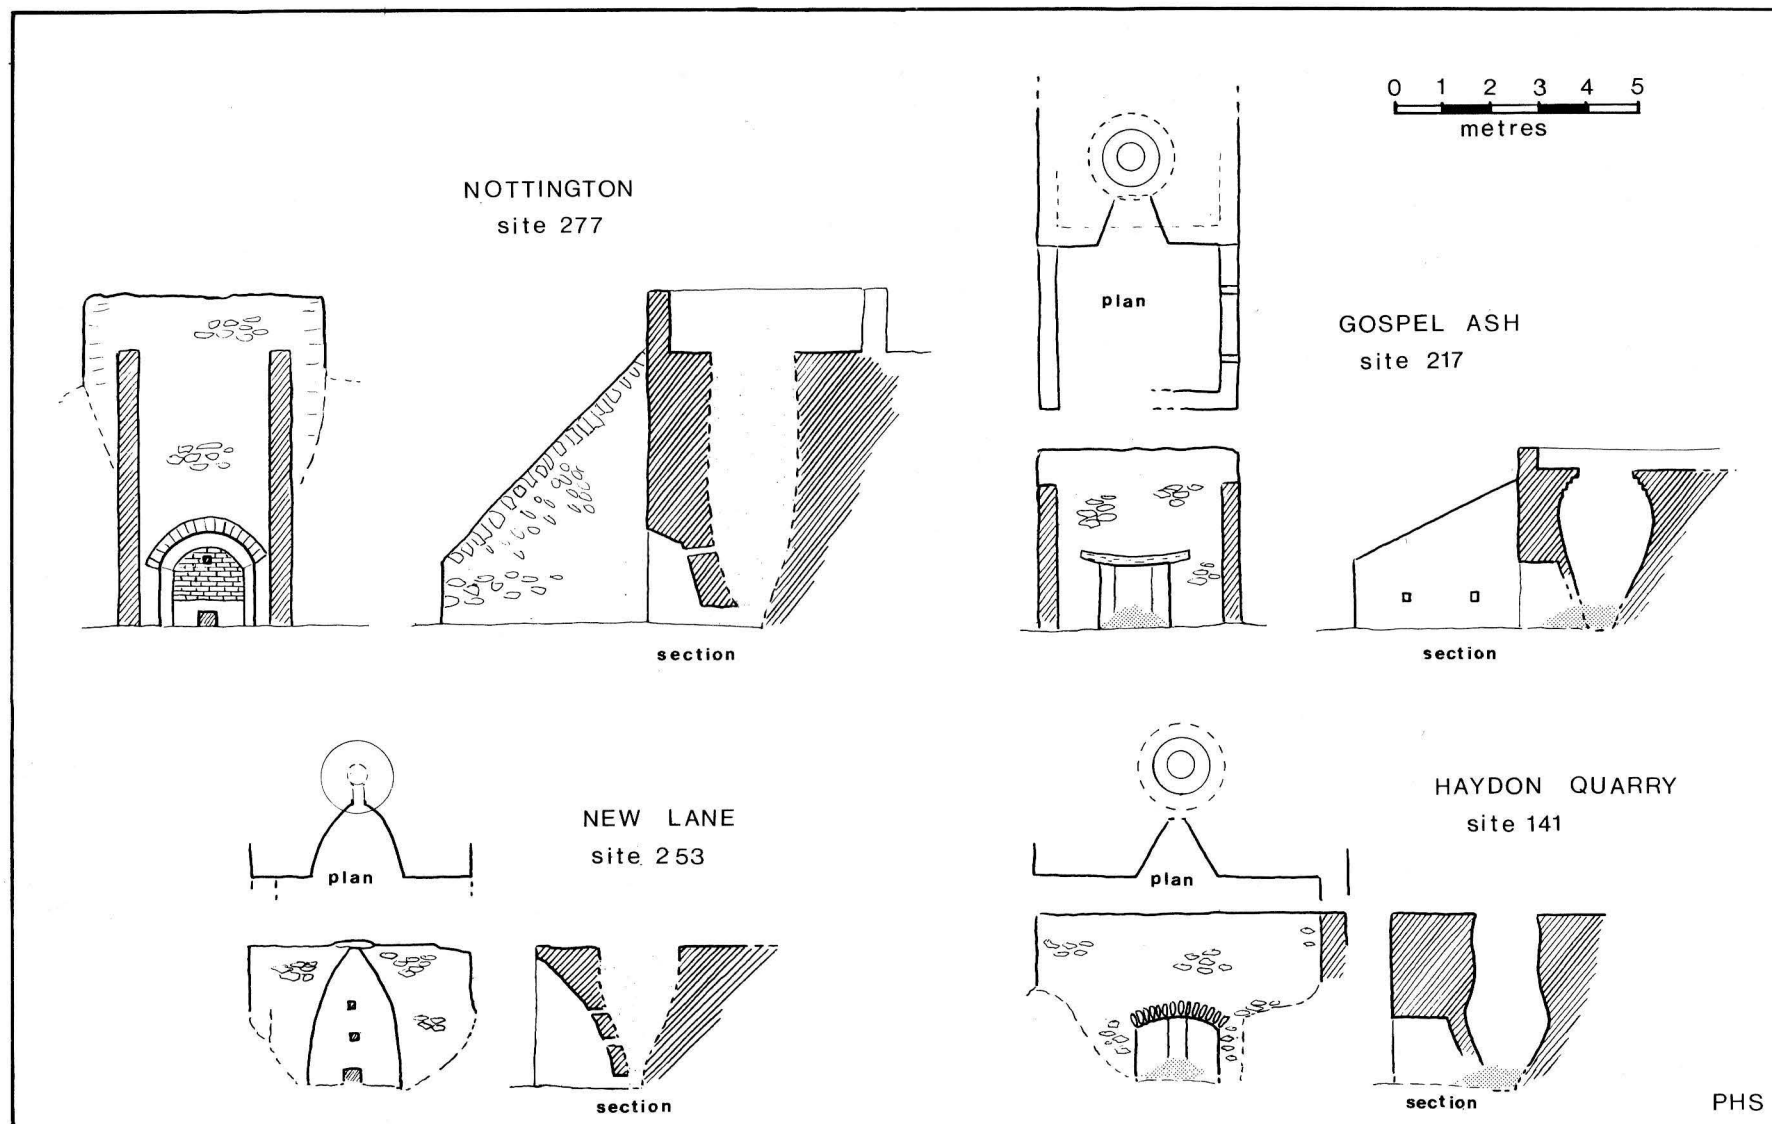
Figure 5. Some Dorset limekilns (part one).

The limekilns are difficult to group according to style, because each was built individually and there is little evidence that any two were built by the same hand (see Figures 5 and 6). However, some general styles can be identified from the most prominent architectural feature, the draw arch. Using this classification, Table 3 groups the known limekilns into seven types (A-G), with the addition of two minor exceptions (types H and I). The arches vary within this simple scheme. For example, pointed arches may have straight or curved sides.
