Loders Lime Kilns

Dorset Limekilns: a first survey

Appendix 1. Limekiln Sites: map evidence and survival

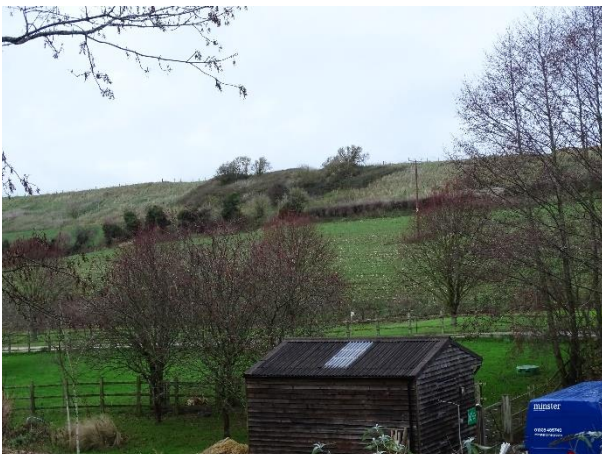
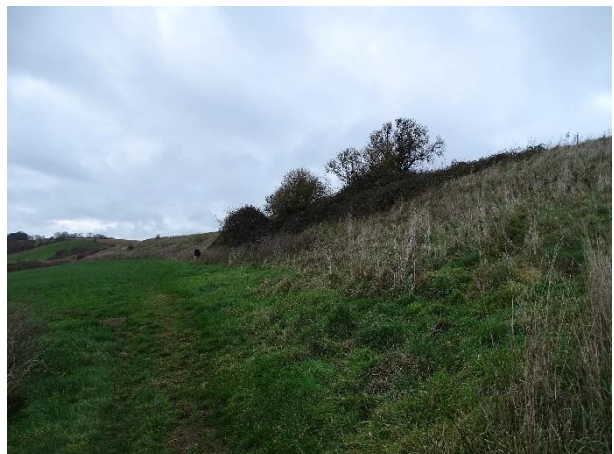
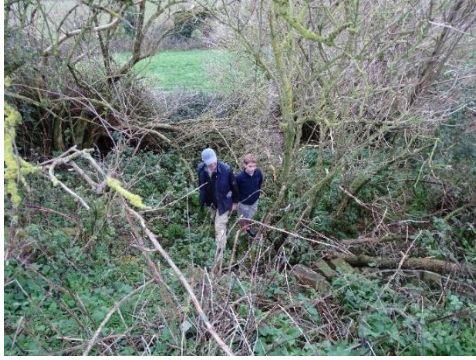
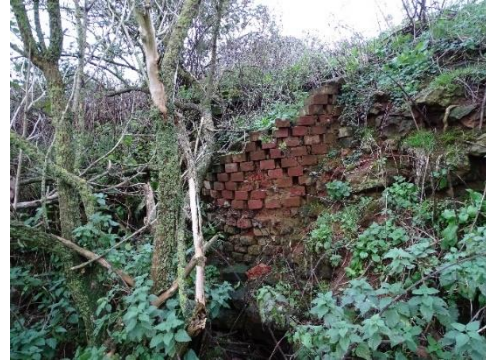
Upton Manor Farm

This kiln appears to have had little use as the internal bricks are not burnt. Inferior oolite quarry at the farm and possible corn brash on hill above. Deteriorating and being overgrown.
